Clunk From Rear Suspension (Supersedes 00-006, dated August 2000)

SYMPTOM

A clunk from the rear suspension when going over rough or bumpy roads.

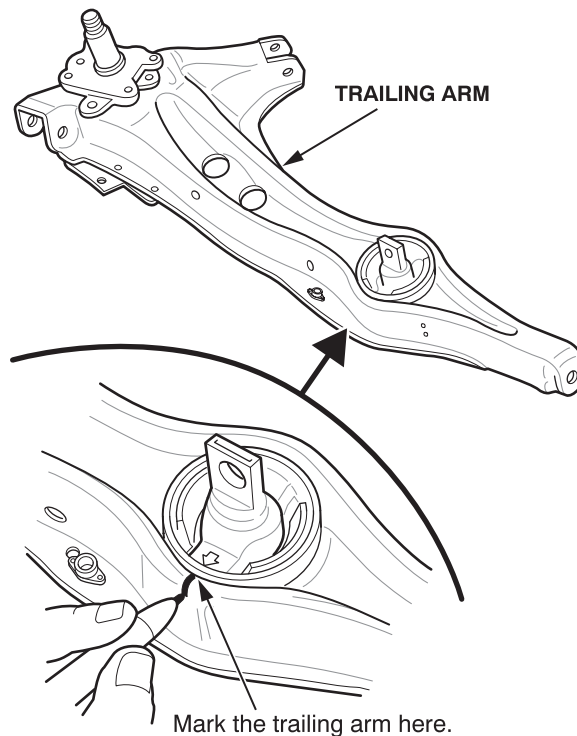
1. Remove the rear trailing arm. Refer to section 18 of the appropriate shop manual.
2. Mark the trailing arm at the top and at the bottom of the bushing.

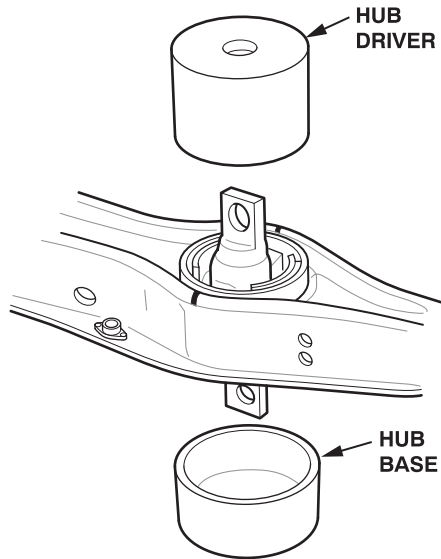
- Place the arm on a hydraulic press, supported by the hub base, with the spindle facing up.

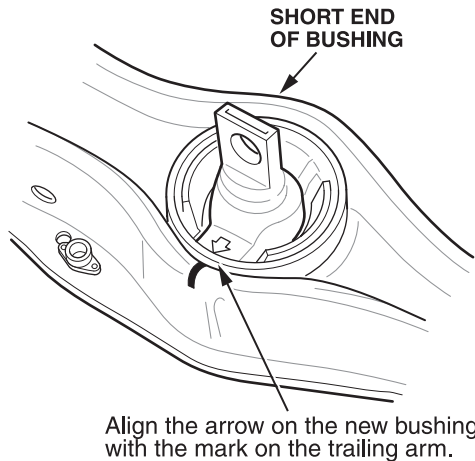
- With the hub driver, press the old bushing out of the trailing arm.
- Install the new bushing with the short end toward the outside of the vehicle. Align the arrow with the mark you made on the trailing arm.

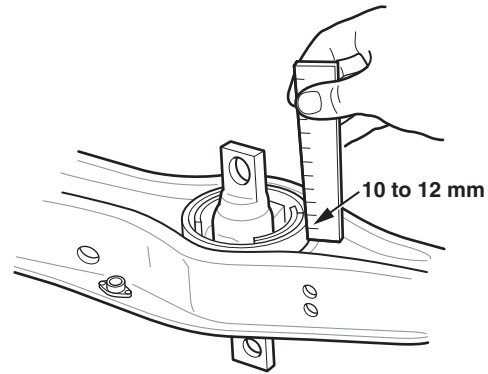
- Press the new bushing into the trailing arm until its edge is 10 to 12 mm above the surface of the arm.

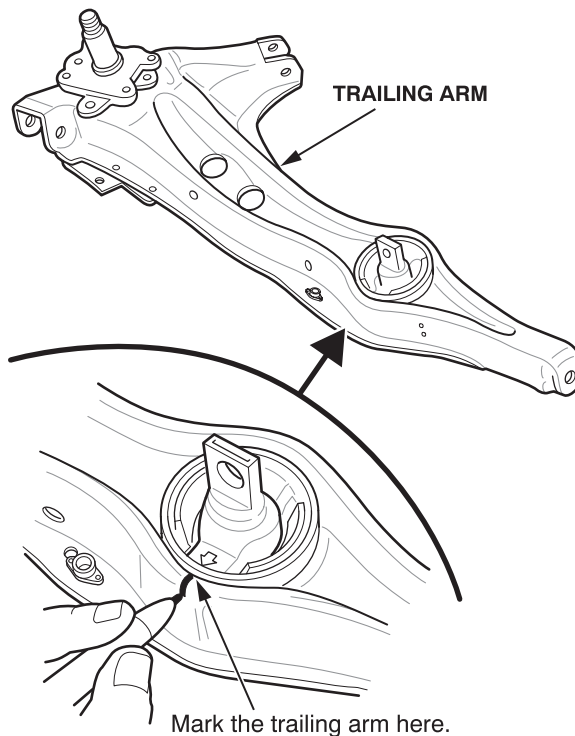
1. Remove the rear trailing arm. Refer to section 18 of the appropriate shop manual.
2. Mark the trailing arm at the top and at the bottom of the bushing.

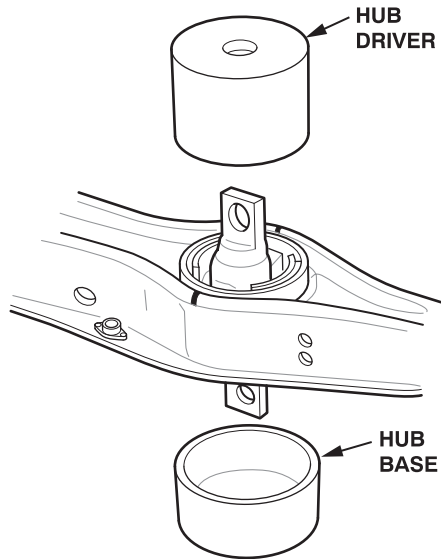
- Place the arm on a hydraulic press, supported by the hub base, with the spindle facing up.

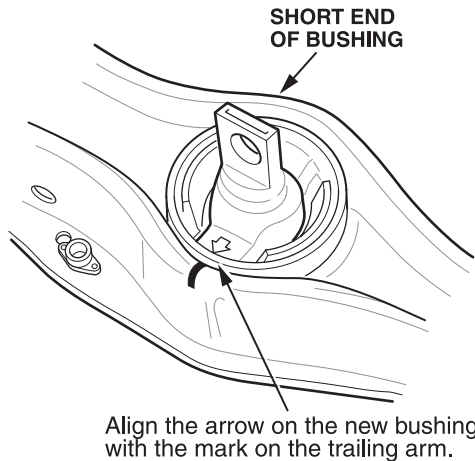
- With the hub driver, press the old bushing out of the trailing arm.
- Install the new bushing with the short end toward the outside of the vehicle. Align the arrow with the mark you made on the trailing arm.

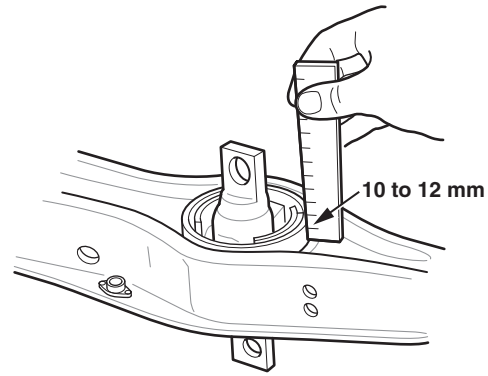
- Press the new bushing into the trailing arm until its edge is 10 to 12 mm above the surface of the arm.

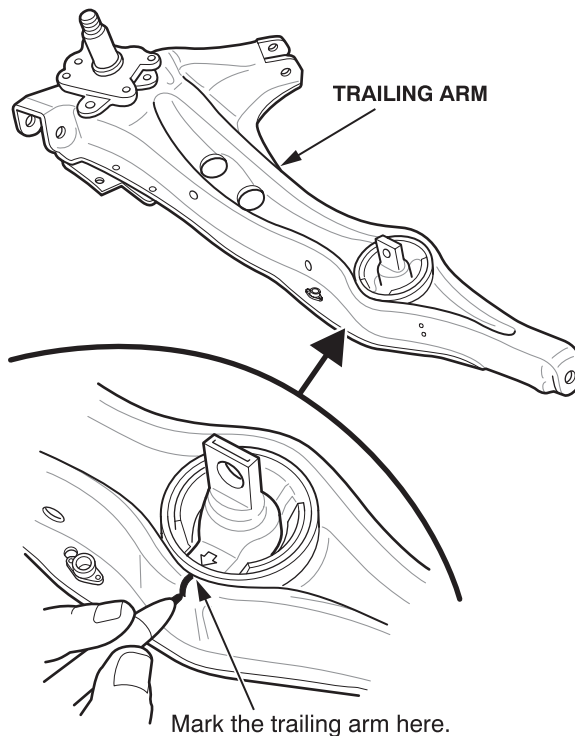
1. Remove the rear trailing arm. Refer to section 18 of the appropriate shop manual.
2. Mark the trailing arm at the top and at the bottom of the bushing.

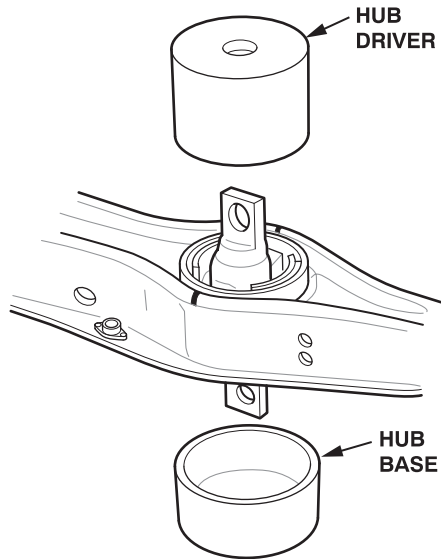
- Place the arm on a hydraulic press, supported by the hub base, with the spindle facing up.

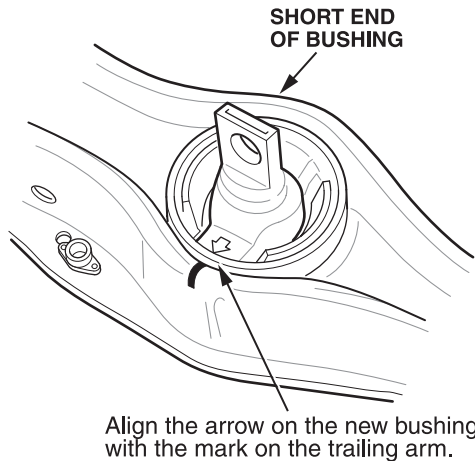
- With the hub driver, press the old bushing out of the trailing arm.
- Install the new bushing with the short end toward the outside of the vehicle. Align the arrow with the mark you made on the trailing arm.

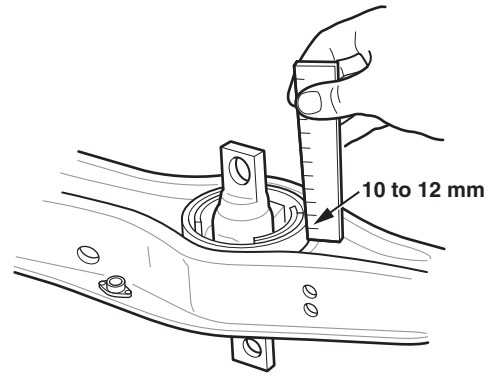
- Press the new bushing into the trailing arm until its edge is 10 to 12 mm above the surface of the arm.
